TEMPORARY NON-VEGETATIVE SOIL
STABILIZATION EVALUATION STUDY
FOR 2000 - 2001 SEASON

Orange County, California
CTSW-RT-01-066

*CALIFORNIA DEPARTMENT OF TRANSPORTATION
ENVIRONMENTAL PROGRAM
1120 N STREET, MS-27
SACRAMENTO, CALIFORNIA 95814*

FEBRUARY 2002

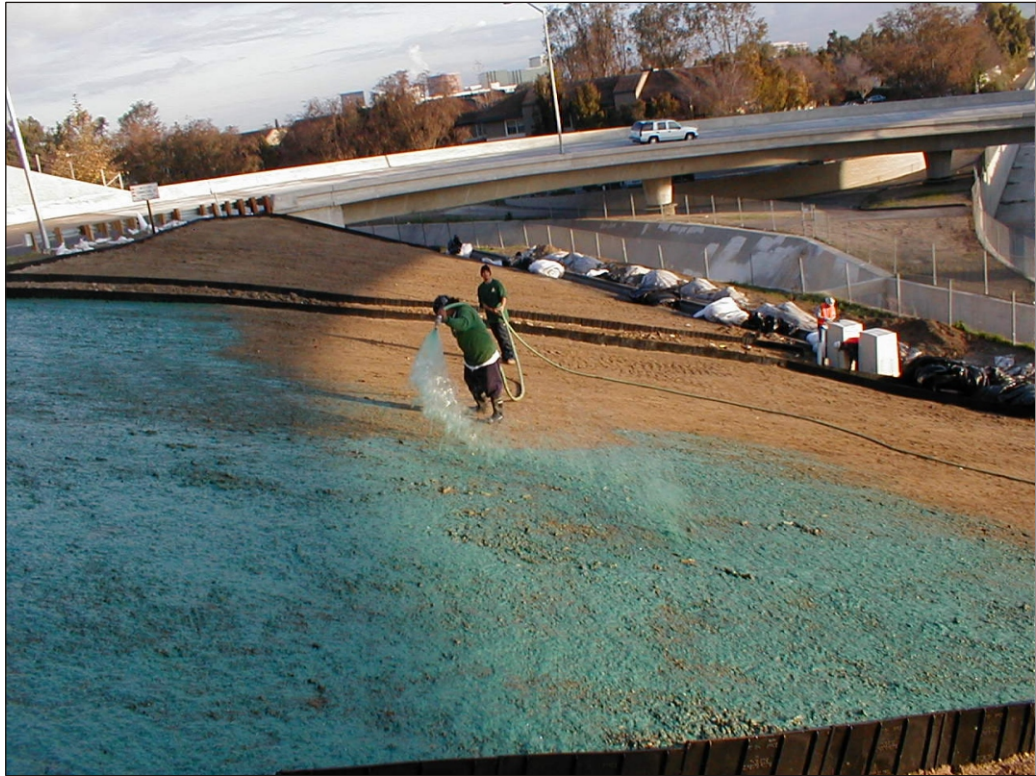
Figure
7

PRODUCT BEING APPLIED TO 12-202
(JANUARY 29, 2001)

PRODUCT A (12-202)

Product A and Product B were applied to test plots 12-202 and 12-203, respectively, at the 55S site. Photographs showing the product application process are present on Figures 7 and 8. Both products were applied on January 29, 2001 under damp climatic conditions. Precipitation occurred the night of January 28, 2001. The slopes were, however, relatively dry during application because they had been covered with plastic sheeting on January 28, 2001 before precipitation had occurred.

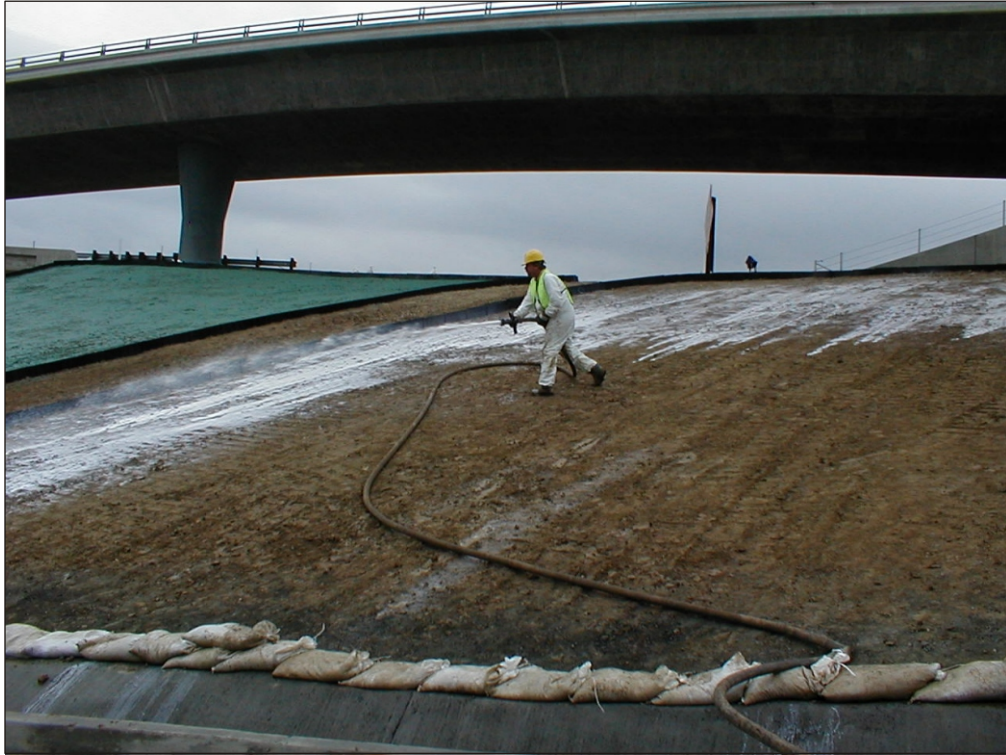
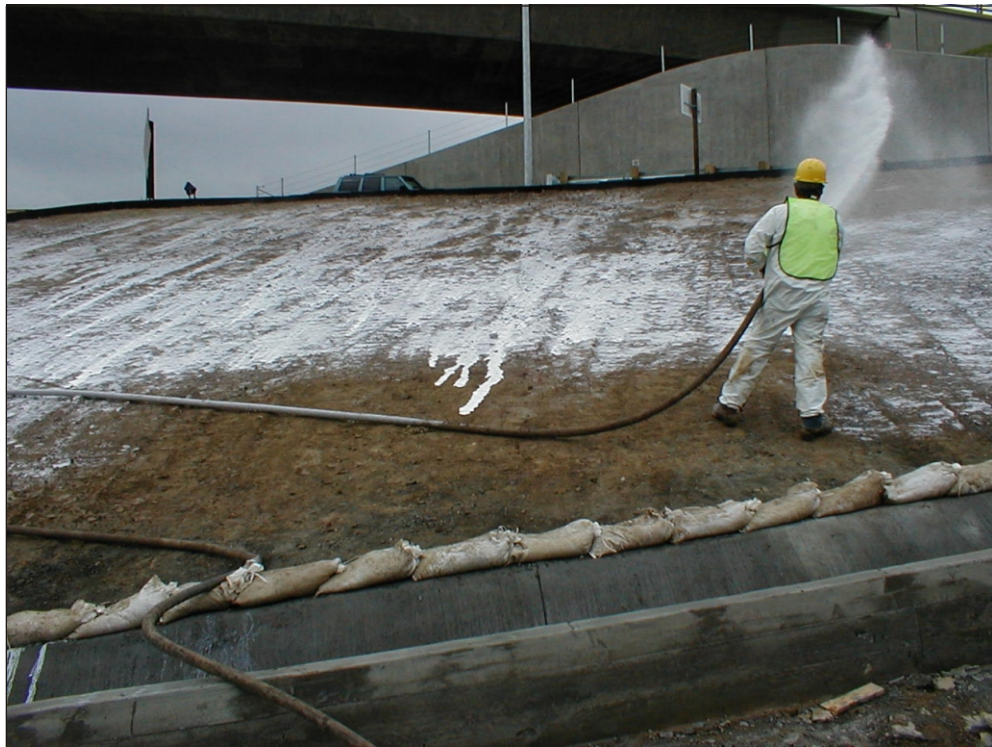
Figure
8

PRODUCT BEING APPLIED TO 12-203
(JANUARY 29, 2001)

PRODUCT B (12-203)

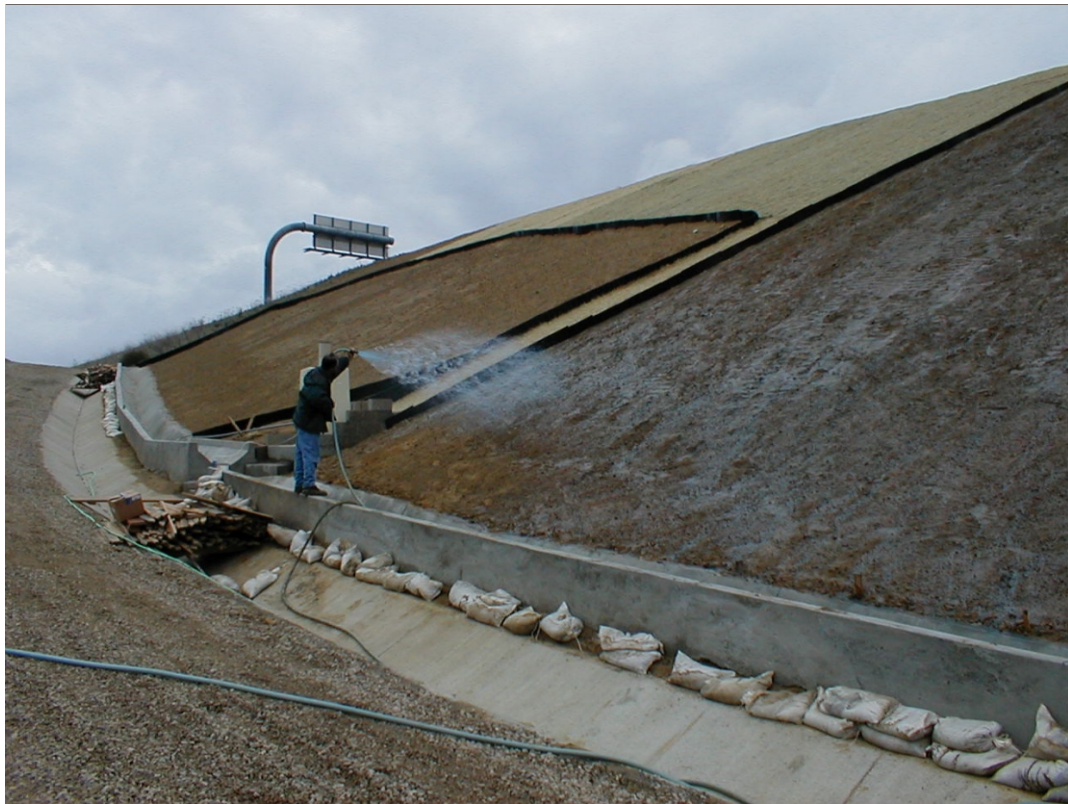
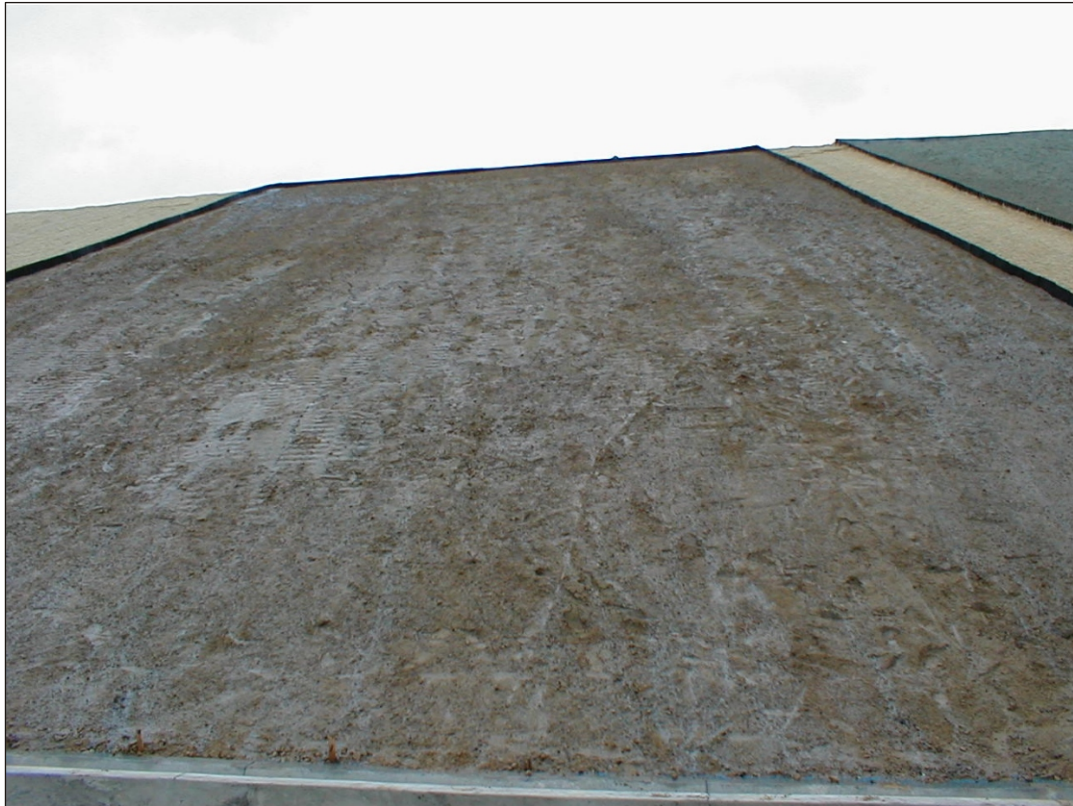
Figure
9

PRODUCT BEING APPLIED TO 12-205
(FEBRUARY 24, 2001)

COMPLETED PRODUCT APPLICATION FOR 12-205
(FEBRUARY 24, 2001)

PRODUCT C (12-205)
PRODUCT APPLICATION
 Temporary Non-Vegetative Soil Stabilization Evaluation Study

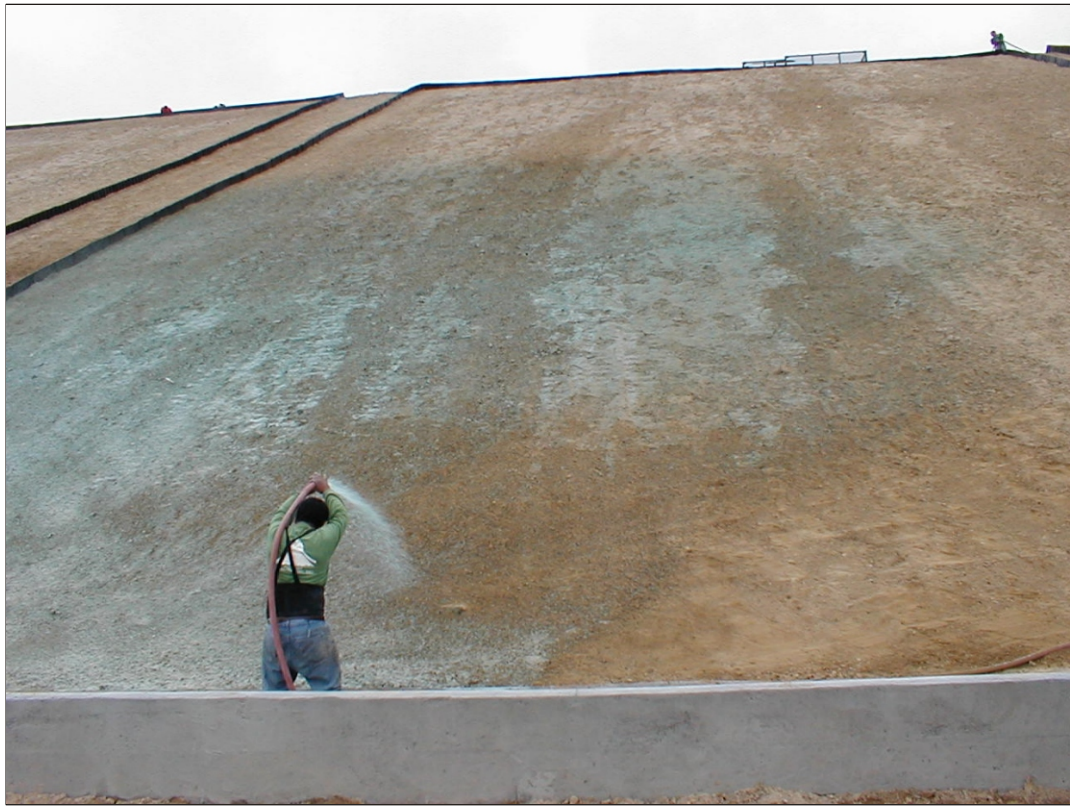
Figure
10

PRODUCT BEING APPLIED TO 12-206
(FEBRUARY 22, 2001)

PRODUCT D (12-206)

Product D was mixed on site using a 1,500-gallon hydromulch machine equipped with mechanical agitators. The Product D mixture contained 1,000 pounds of the gypsum product, 300 pounds of mulch and 600 gallons of water. The slurry was continuously agitated during application to maintain a homogenous state. A 2-inch fire hose was used to pressure-spray the product slurry onto the slope from the slope toe to slope crest, at a rate of 5,000 pounds per acre of land. Dry and warm climatic conditions enabled the product to thoroughly dry and set.

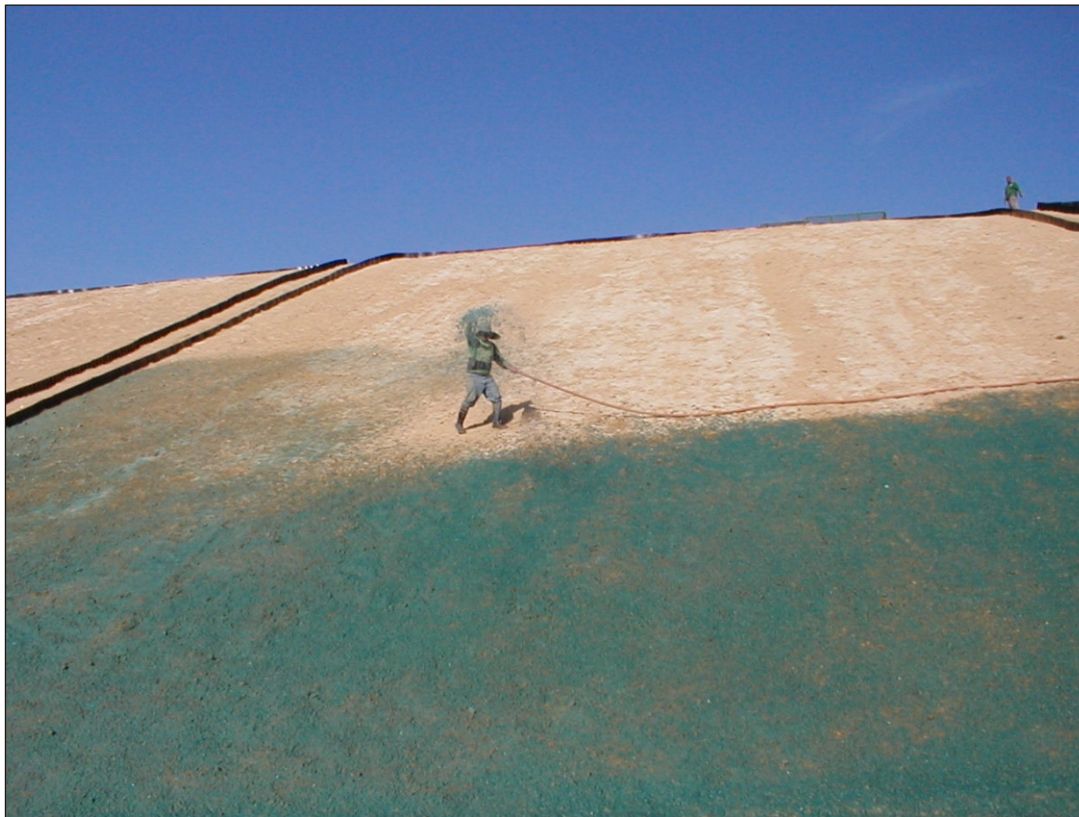
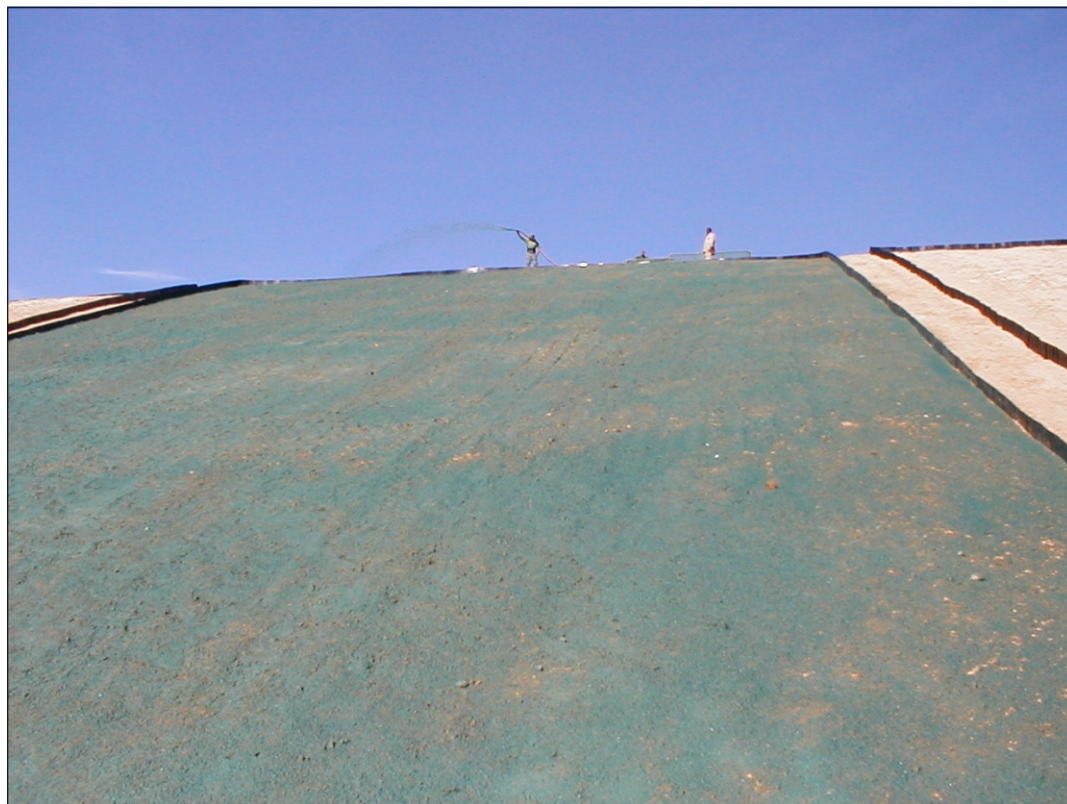
PRODUCT BEING APPLIED TO 12-207
(FEBRUARY 21, 2001)

<p>PRODUCT E (12-207)</p> <p>PRODUCT APPLICATION</p> <p>Temporary Non-Vegetative Soil Stabilization Evaluation Study</p>	<p>Figure by AY</p>	<p>Project No. 5865.003</p>
		<p>Date 02/12/02</p>	<p>Figure 11</p>

Product E was mixed into a slurry on site using a 1,500-gallon hydromulch machine equipped with mechanical agitators, at a ratio of 5 pounds of product to 325 pounds of mulch and 600 gallons of water. The slurry was continuously agitated to maintain a relatively homogenous mixture during the application process. The slurry was sprayed over the slope surface with a 2-inch diameter fire hose at an application rate of 25 pounds of product per acre of land. The product was applied from the slope toe up to the crest. Climatic conditions were warm and dry after application, enabling the product mixture to thoroughly dry and set.

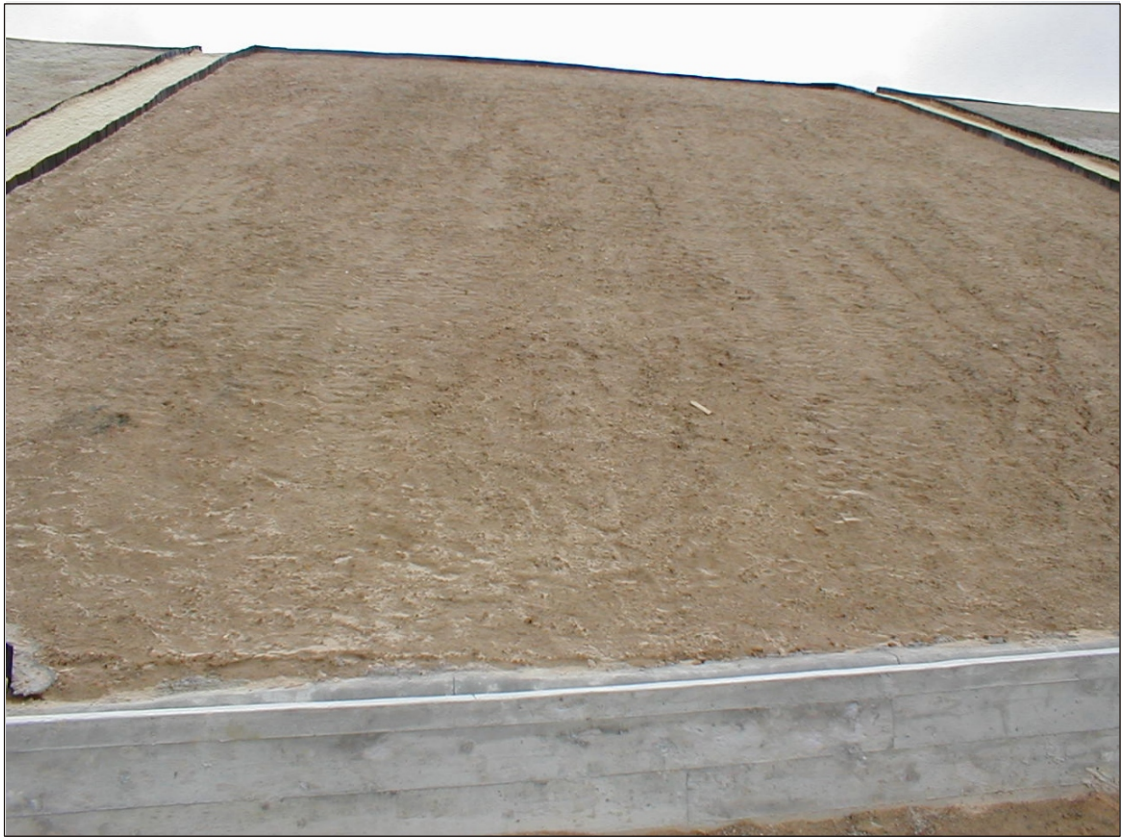
CONDITION OF PLOT 12-208
ON MARCH 7, 2001

PRODUCT F (12-208) Temporary Non-Vegetative Soil Stabilization Evaluation Study	Figure by AY	Project No. 5865.003
			Figure 12
		Date 02/12/02

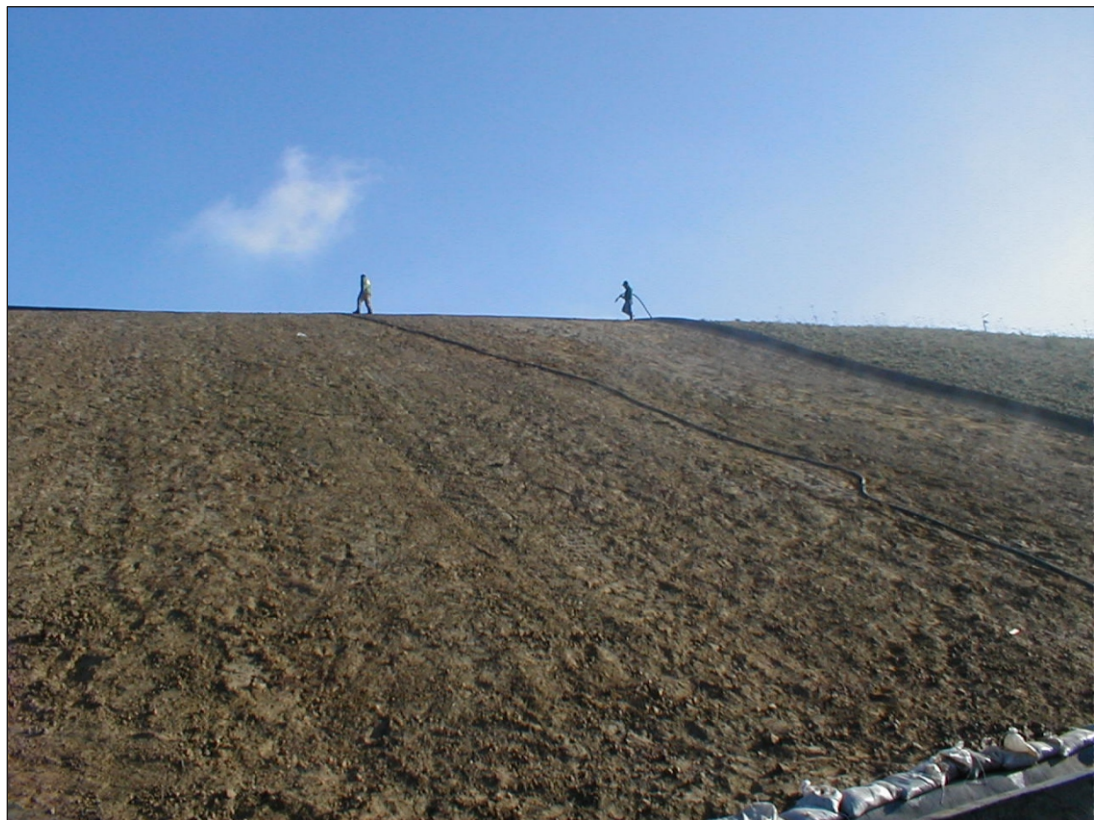
PRODUCT BEING APPLIED TO 12-209
(FEBRUARY 22, 2001)

<p>PRODUCT G (12-209)</p> <p>PRODUCT APPLICATION</p> <p>Temporary Non-Vegetative Soil Stabilization Evaluation Study</p>	Figure by AY	Project No. 5865.003
			Figure
		Date 02/12/02	13

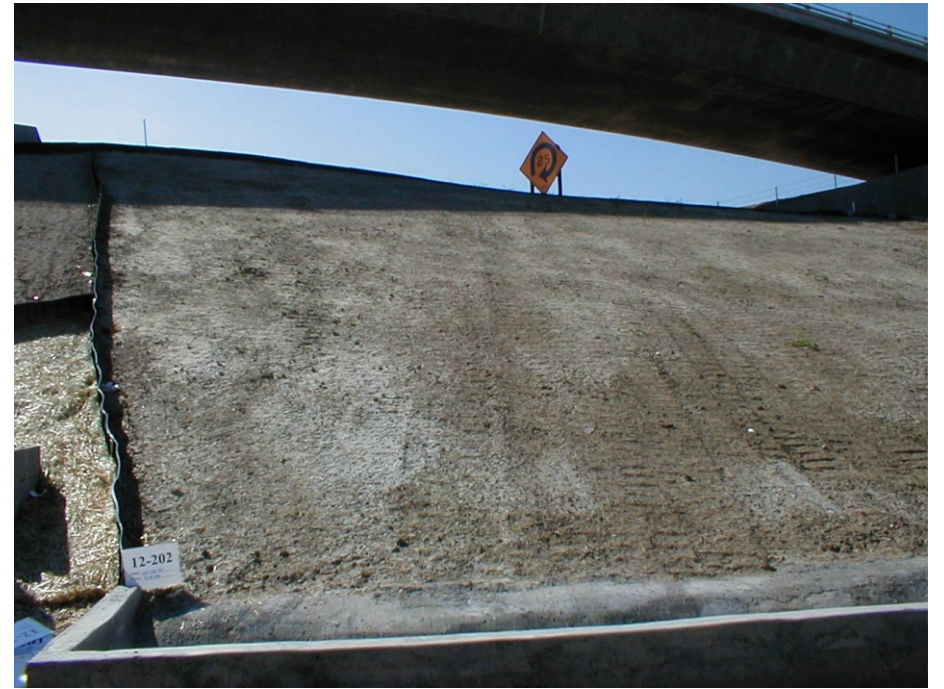
PRODUCT B (12-203)
TIME-SERIES SEQUENCE
Temporary Non-Vegetative
Soil Stabilization Evaluation Study

Figure 18 shows a time-series progression of the Product B test plot. During the storm events, minor soil erosion was observed and removal of sediment from the flume was occasionally required. Sediment loading impeded the accuracy of flow measurements and increased the number of sample aliquots collected during intense portions of the storm events on February

10, February 26, and April 7, 2001. Moderate evidence of foaming was observed in the runoff discharged from the flume during the February 10 and February 26, 2001 storm events.

Slight rill formation was observed near the northwest and southeast borders of the Product B test plot during the April 7, 2001 storm monitoring event. However, the product appeared to remain intact during the 2000-2001 storm monitoring season.

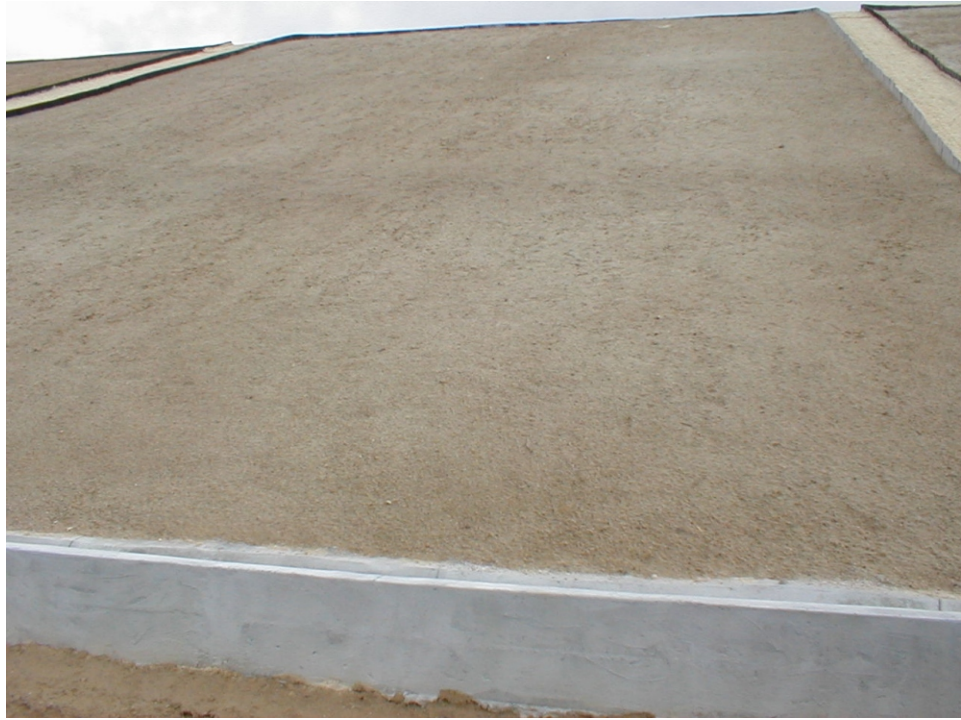
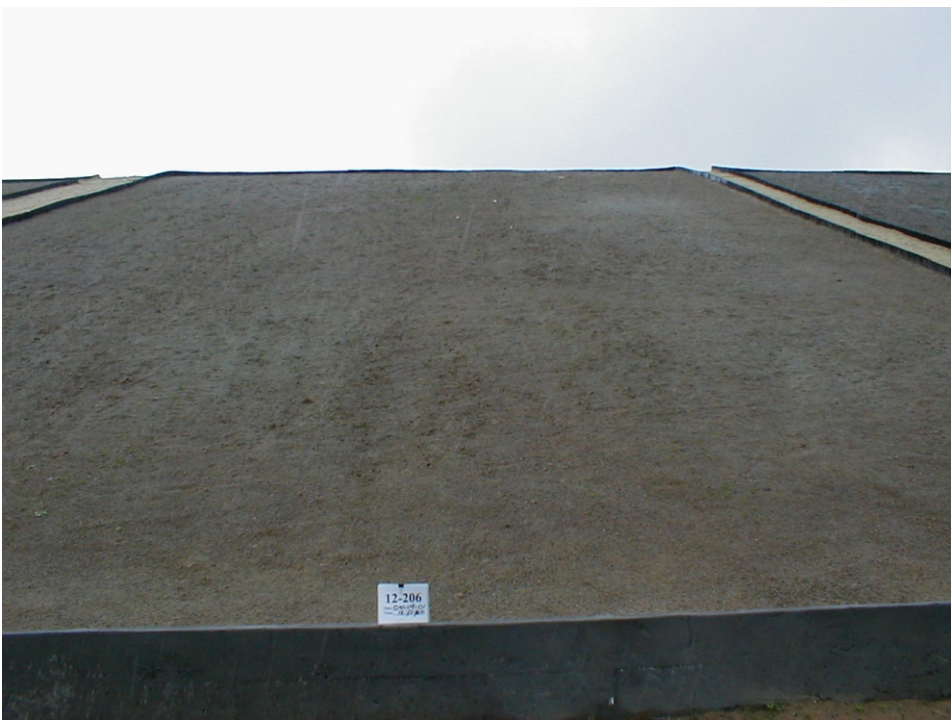
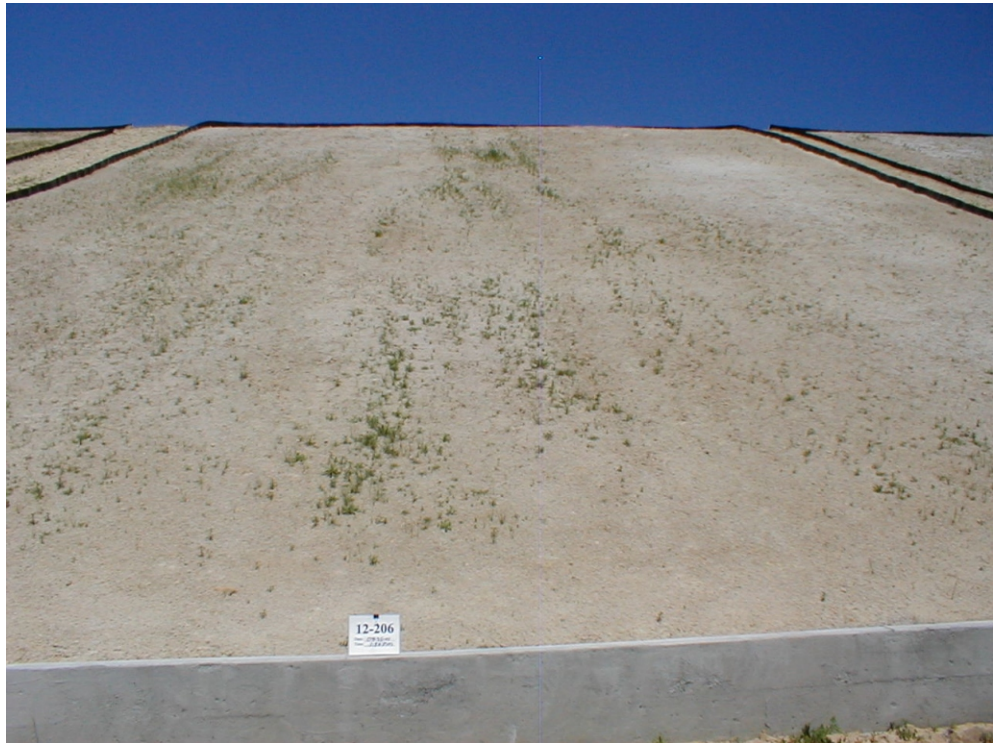
Figure by AY		Figure 20
Date 02/12/02	Project No. 5865.003

PRODUCT C (12-205)
TIME-SERIES SEQUENCE
Temporary Non-Vegetative
Soil Stabilization Evaluation Study

half the size of the other test plots at the 73S site for the February 26 and March 6, 2001 storm events. During the intense periods of rainfall, moderate sediment accumulation was observed in the flume and near the intake of the automatic sampler that impeded the accuracy of the level measurements obtained from the bubbler.

Shallow rill formation was observed in the lower portion of the test plot during the April 7, 2001 storm event. During the April 21, 2001 storm event, shallow rill formation was observed throughout the entire test plot, with the deepest rills observed in the lower portion of the slope.

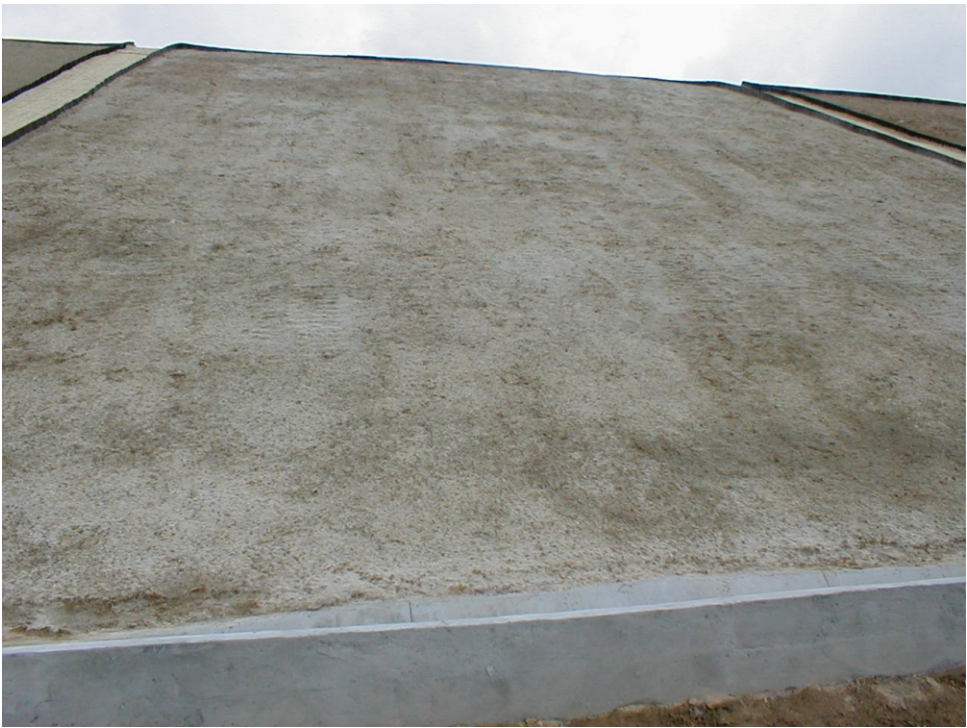
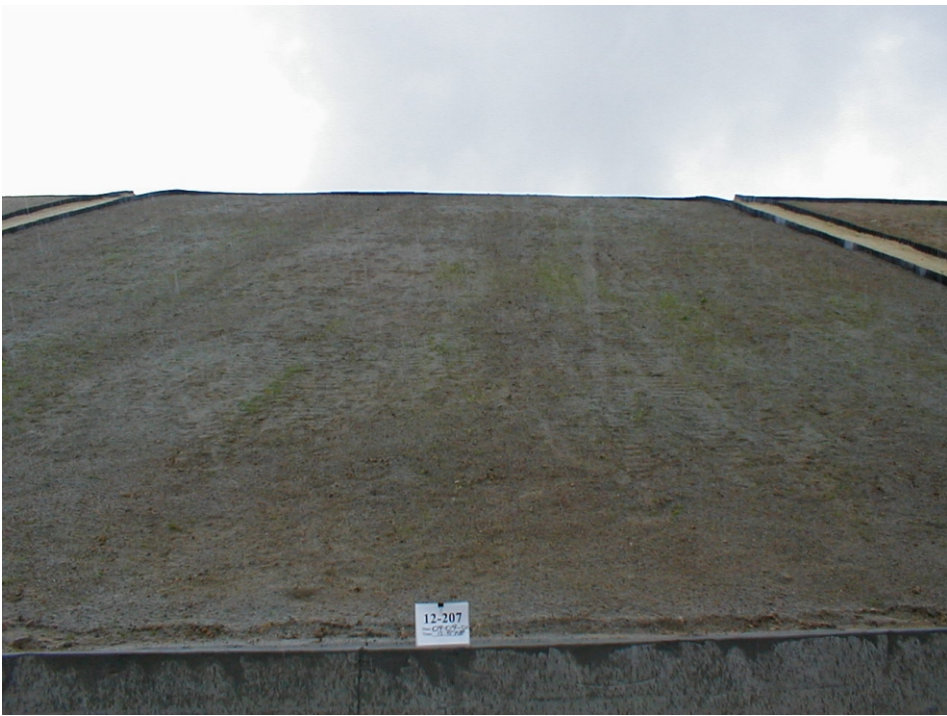
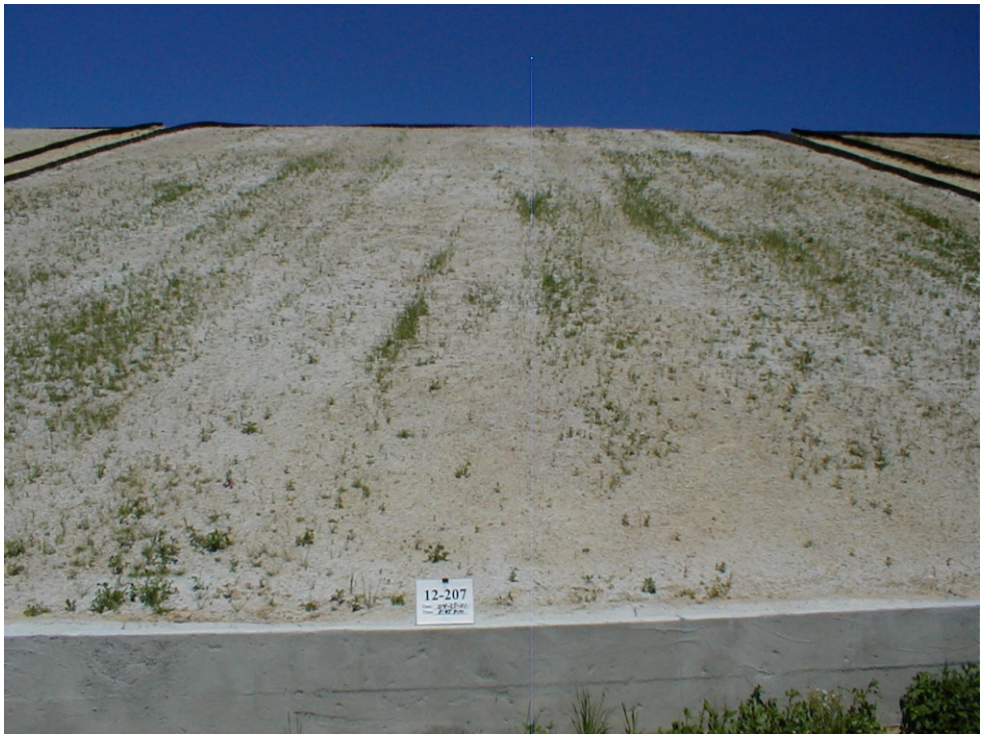
PRODUCT D (12-206)
TIME-SERIES SEQUENCE
Temporary Non-Vegetative
Soil Stabilization Evaluation Study

Figure 21 shows a time-series progression of the Product D test plot. Very little sediment accumulation was observed in the flume and intake of the automatic sampler during the storm events and sediment accumulation did not appear to affect flow measurements obtained from the Product D test plot.

Slight rill formation was observed in the central portion of the test plot during the April 7, 2001 storm event. During the April 21, 2001 storm event, shallow rill formation was observed

throughout the test plot with the deepest rills observed on the lower, southeastern, and northwestern portions of the slope.

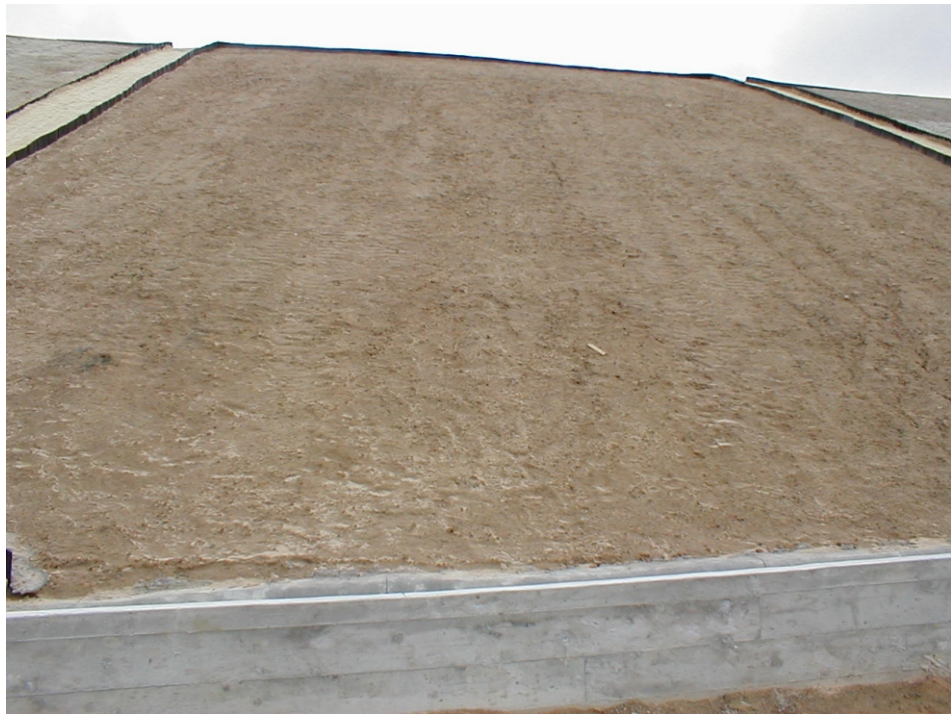
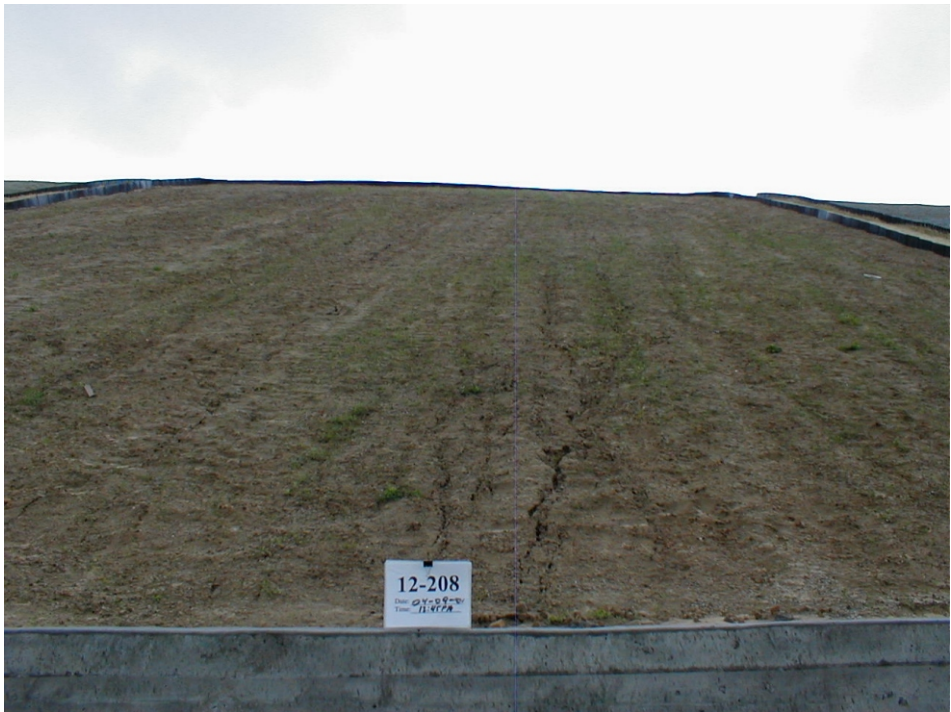
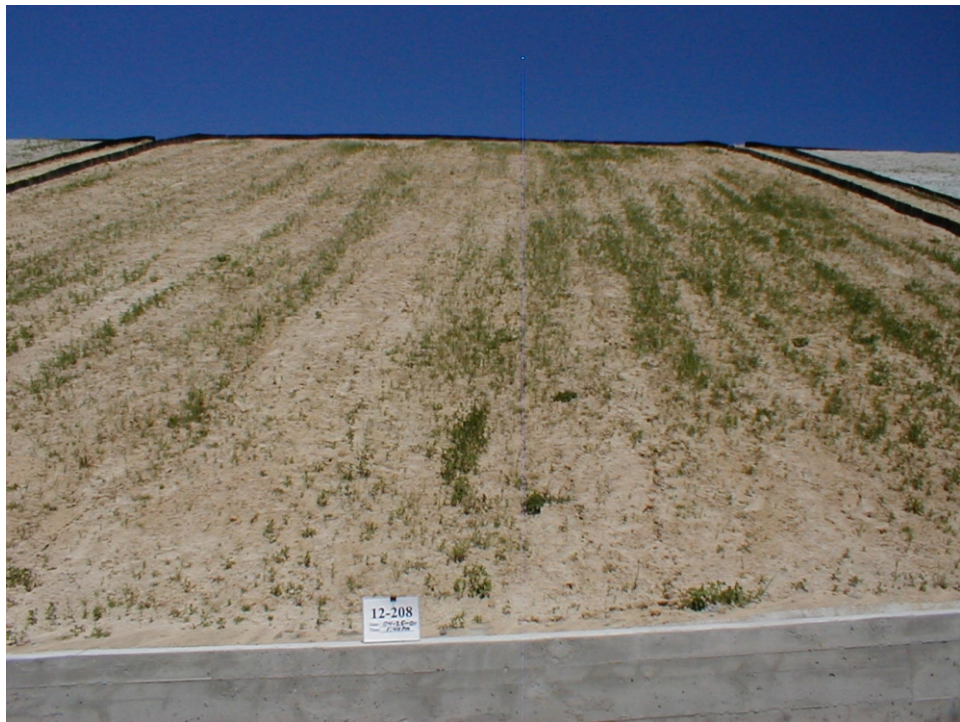
Figure by AY		Figure 22
	Date 02/12/02	Project No. 5865.003

PRODUCT E (12-207)
TIME-SERIES SEQUENCE
Temporary Non-Vegetative
Soil Stabilization Evaluation Study

Figure 22 shows a time-series progression of the Product E test plot. During the February 26 and March 6 storm events, very little sediment accumulation was observed in the flume and intake of the automatic sampler. Sediment accumulation during these storm events did not appear to affect flow measurements obtained from the Product E test plot.

During the April 7 and April 21, 2001 storm events, moderate sediment accumulation was observed in the flume and near the intake of the automated sampler for this test plot. During periods of intense rainfall, the runoff appeared to be turbid and contained a significant amount of sediment. The sediment load impeded the accuracy of flow measurements.

Rill formation was observed in the upper northeastern and central portions of the test plot during the April 7, 2001 storm event. Product E appeared to have been washed off in small areas of the test plot. During the April 21, 2001 storm event, shallow rill formation was observed throughout the test plot with the deepest rills observed on the lower, southeastern, and northwestern portions of the slope.

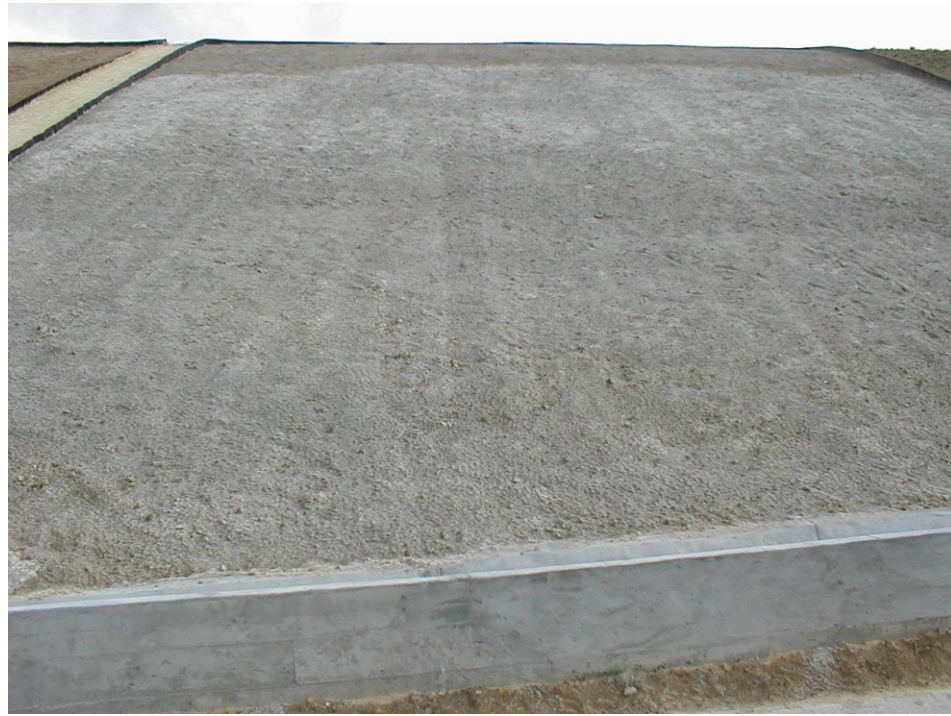
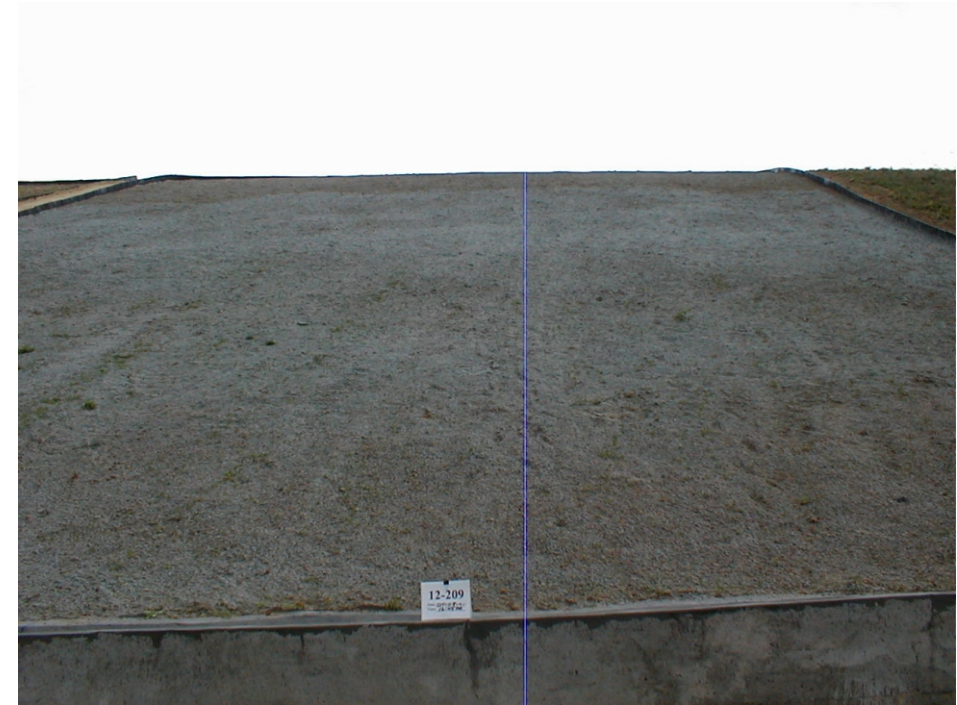
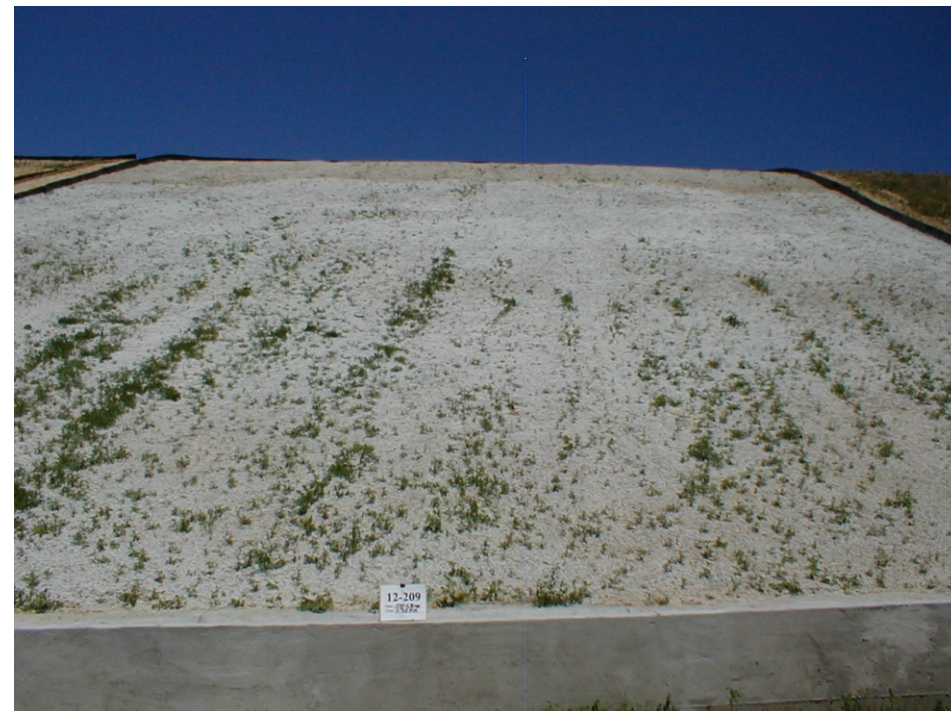
Figure by AY		Figure 23
	Date 02/12/02	Project No. 5865.003

PRODUCT F (12-208)
TIME-SERIES SEQUENCE
Temporary Non-Vegetative
Soil Stabilization Evaluation Study

Figure 23 shows a time-series progression of the Product F test plot. During the February 26 and March 6 storm events, very little sediment accumulation was observed in the flume and intake of the automatic sampler. Sediment accumulation during these storm events did not appear to affect flow measurements obtained from the Product F test plot. During the April 7 and April 21, 2001 storm events, major sediment accumulation was observed in the flume and near the intake of the automated sampler for this test plot. During periods of intense rainfall,

Rill formation was observed in the lower right-central portion of this slope during the March 6, 2001 monitoring event and deepened and widened with subsequent storm events. Small (1- to 2-inch diameter) animal burrow holes were observed before the April 7, 2001 storm.
